NASA/TM-2017-219611

Autonomous Inspection of Electrical Transmission Structures with Airborne UV Sensors

NASA Report on Dominion Virginia Power Flights of November 2016

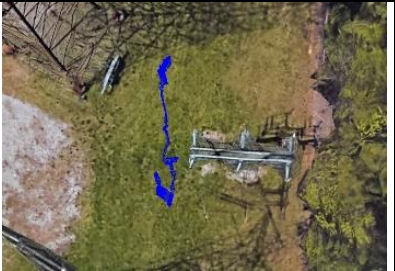
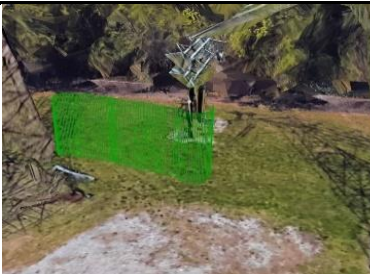
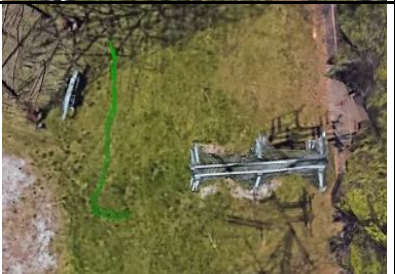
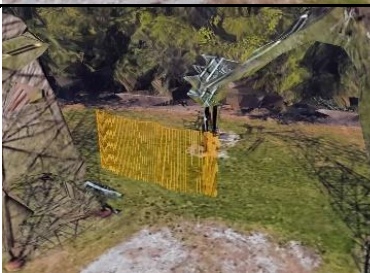
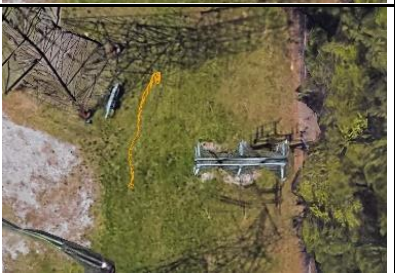
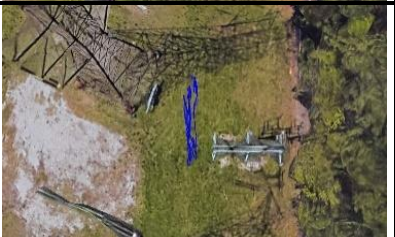
Figure 7. UV signal plot and autopilot flight path for the tower test flights. As with the substation flights, the standoff distance is 12' for manual flights and 20' for autonomous flights. The outputs from the compact UV sensor, recorded in the autonomous flights, show no signal, due to a corona generator malfunction. ©Map data: Google, DigitalGlobe & NASA

Medium-altitude flight maneuvers and sensor checks were accomplished in the tower (T) test flights (top of Table 2; Figure 7)³. A back-and-forth manual flight with increasing altitude (T1_1) was executed to frame the UAV in the corona camera's field of view and to set waypoints for an autonomous flight. In two subsequent autonomous flights on day 1 (T1_3 and T1_4), the UAV failed to detect an ultraviolet signal and drifted off of the planned flight path halfway between the waypoints. The detection failure was due to a poor contact between the corona generator's body and its emitting tip.
